Colchester's Roman Walls

A CITY GUIDE

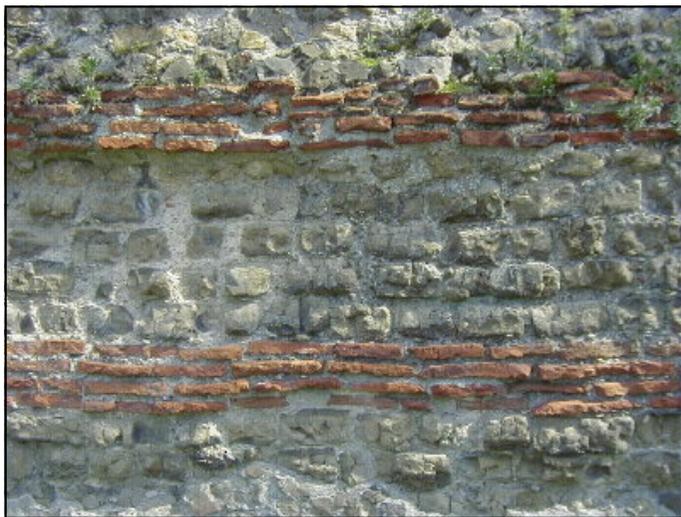
The construction of the wall was of an 'ashlar' construction. A foundation base was laid down and then an inner and an outer wall was built, with a rubble infill, as this drawing shows. A clear demonstration of this can be seen at the 1980s breach of this Scheduled Ancient Monument, that was permitted in St John's Street to give underground access to the new Culver Precinct.

Each inner and outer wall was precisely laid in a set number of courses, with around five septaria courses, followed by four fired tile courses. It was a thorough and precise bit of work, unsurpassed in modern times.

The Romans realised that there was no natural building stone in this part of Essex, so they had to find alternatives. A material known as 'septaria' (a compacted clay) occurs naturally on the beaches of Harwich and Walton-on-the-Naze and this had to be dug out and brought back. Also, Essex's geology provided them with boulder clay that could be fired to make bricks. Remember that the area would have been heavily forested at that time so

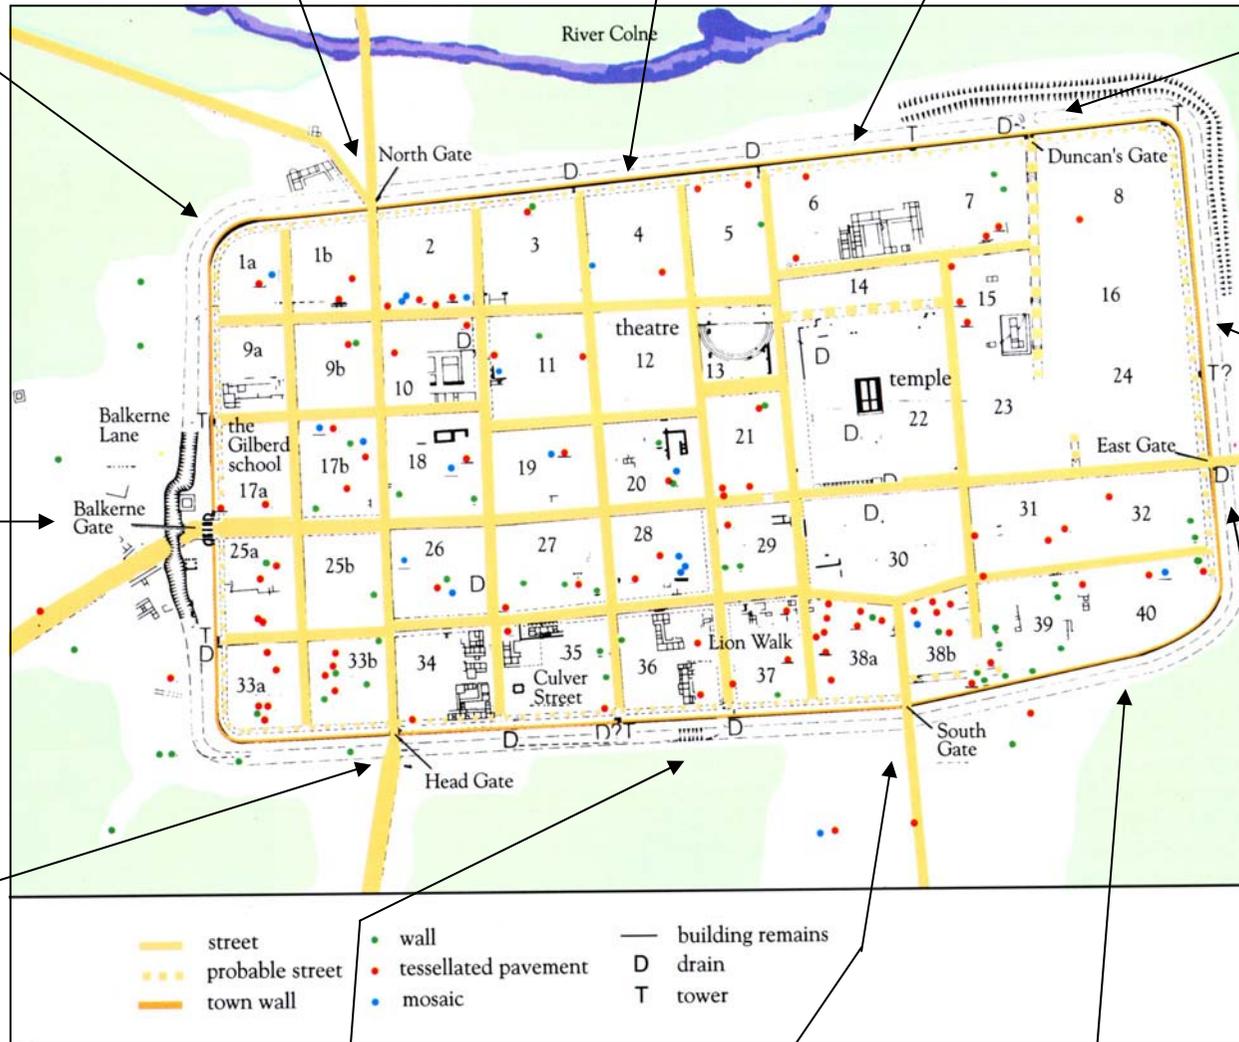
The map on the front page of this leaflet shows the modern day outline of the town wall with its principal points marked. The large map on the inside of the leaflet was created by archaeologists and shows what is known of how the Roman colonia was laid out over the period of years of the Roman occupation (AD 43 to 410). It was divided into sections known as 'insulae'. Interestingly, many of our modern day roads aligned with the original Roman roadways.
